AMMRC CTR 76-31 ✓

BRITTLE MATERIALS DESIGN, HIGH TEMPERATURE GAS TURBINE

Arthur F. McLean, Ford Motor Company, Dearborn, Michigan 48121
Robert R. Baker, Ford Motor Company, Dearborn, Michigan 48121

Interim Report Number 10, January, 1976 to June 30, 1976

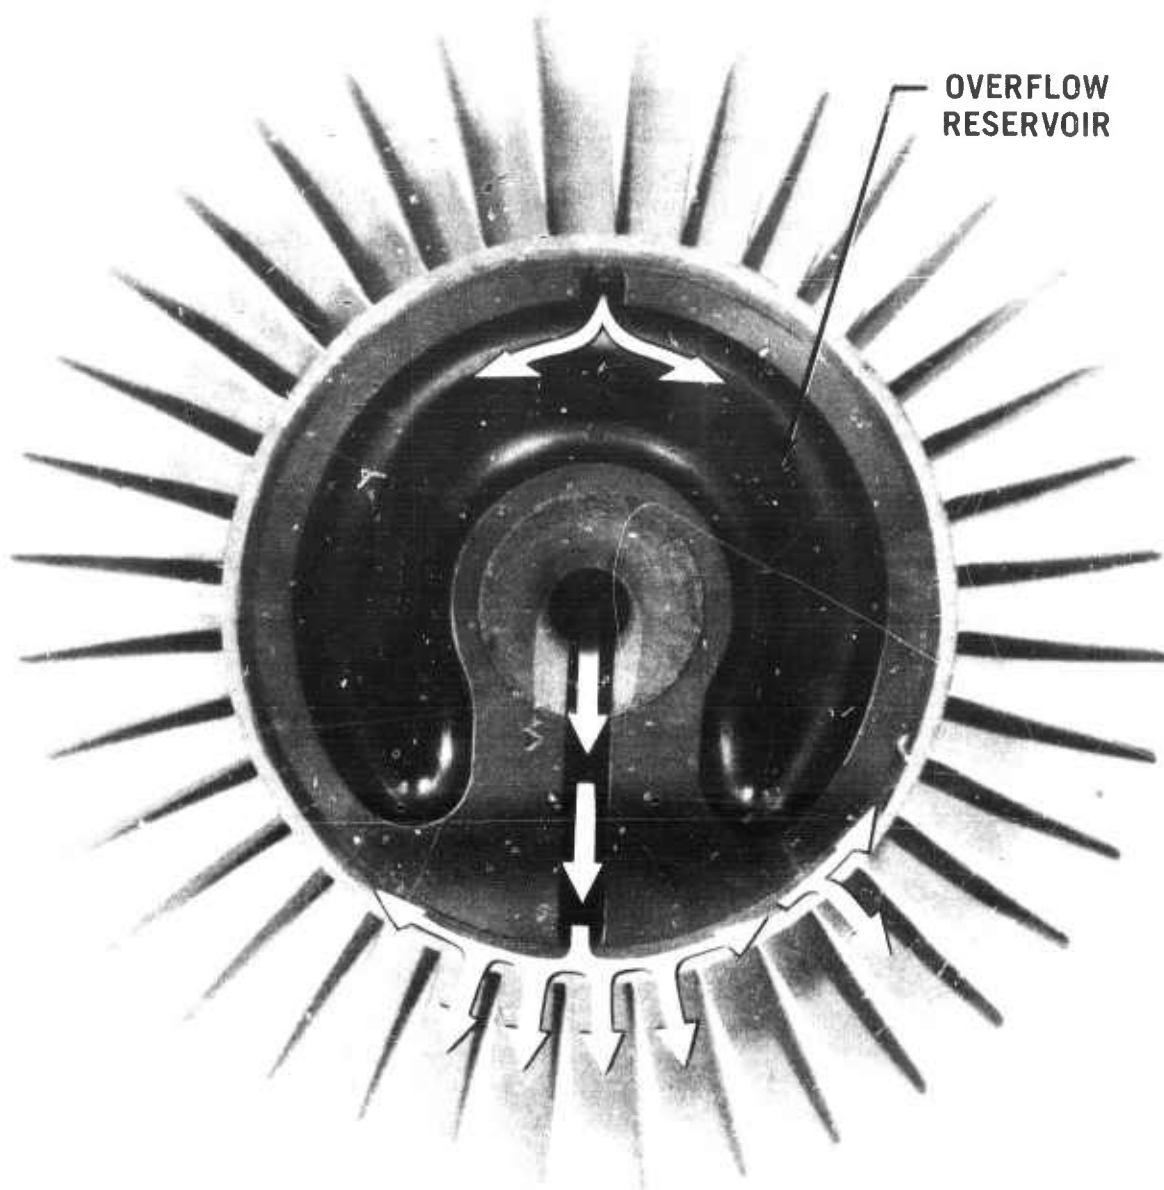
Figure 3.18 Overflow Reservoir on D' Rotor Tooling.

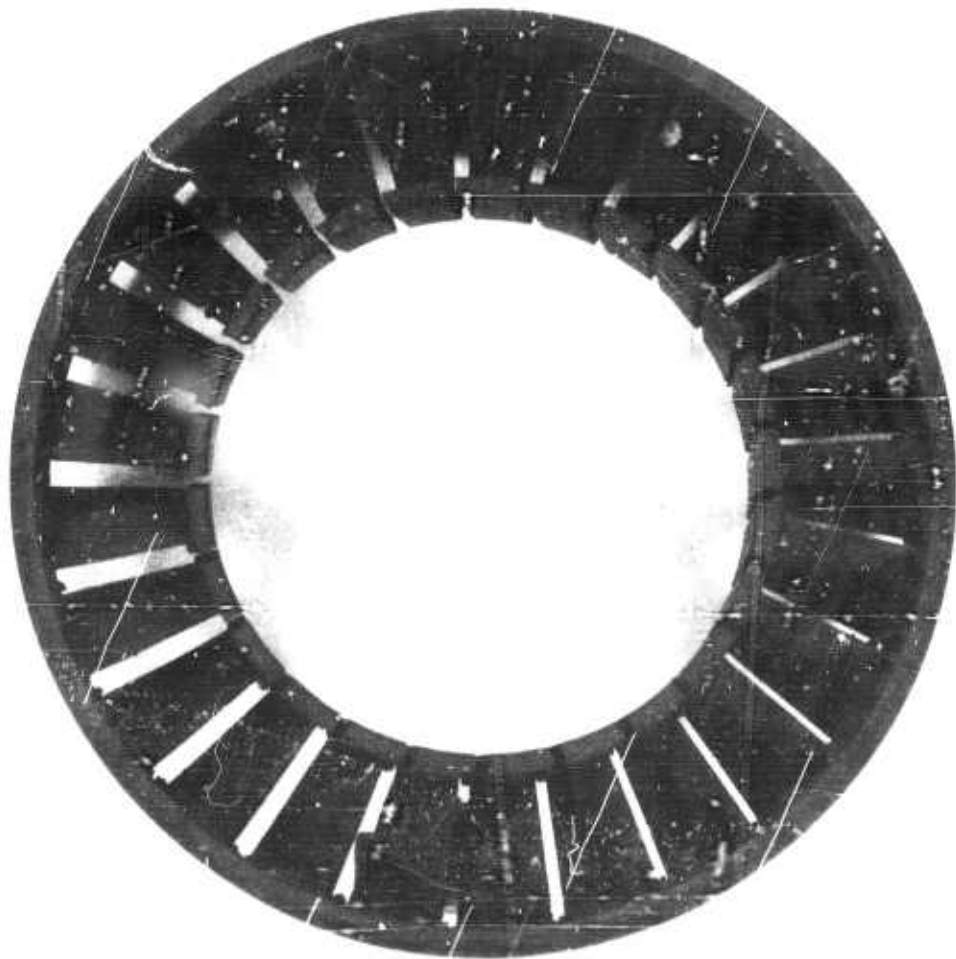
Figure 3.40 Silicon Carbide Stator #525 After 117 Hours at 1930°F in an
Engine Test Rig
